Test Report

**Description : Mobile Data Terminal Model/Type :
C70**

Results of Test

- Drop Test

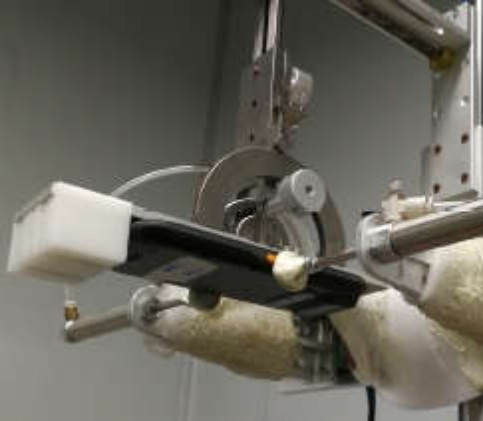
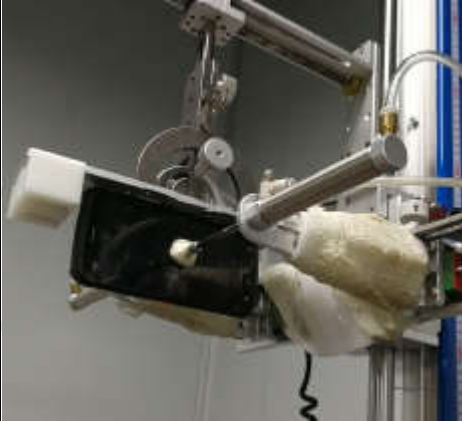
No.6-1 Test Setup	
rear side	left side

- Drop height: 1.8m.
- Drop plate: marble
- Drop sequence :
- 1. A flat drop on the rear side
- 2. A flat drop on the left side
- 3. A flat drop on the right side
- 4. A flat drop on the top side
- 5. A flat drop on the bottom side
- 6. A flat drop on the front side
- 7. Repeat procedure 1-6 for 3 times
- 8. A flat drop on the left side for 1 time
- 9. A flat drop on the right side for 1 time

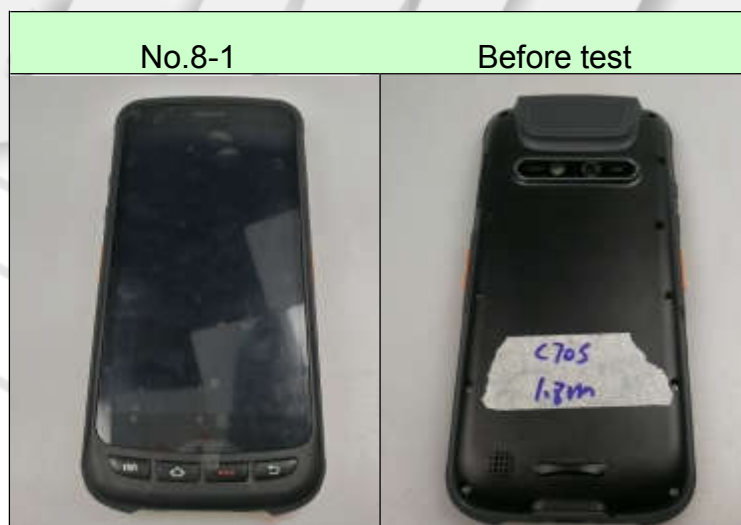
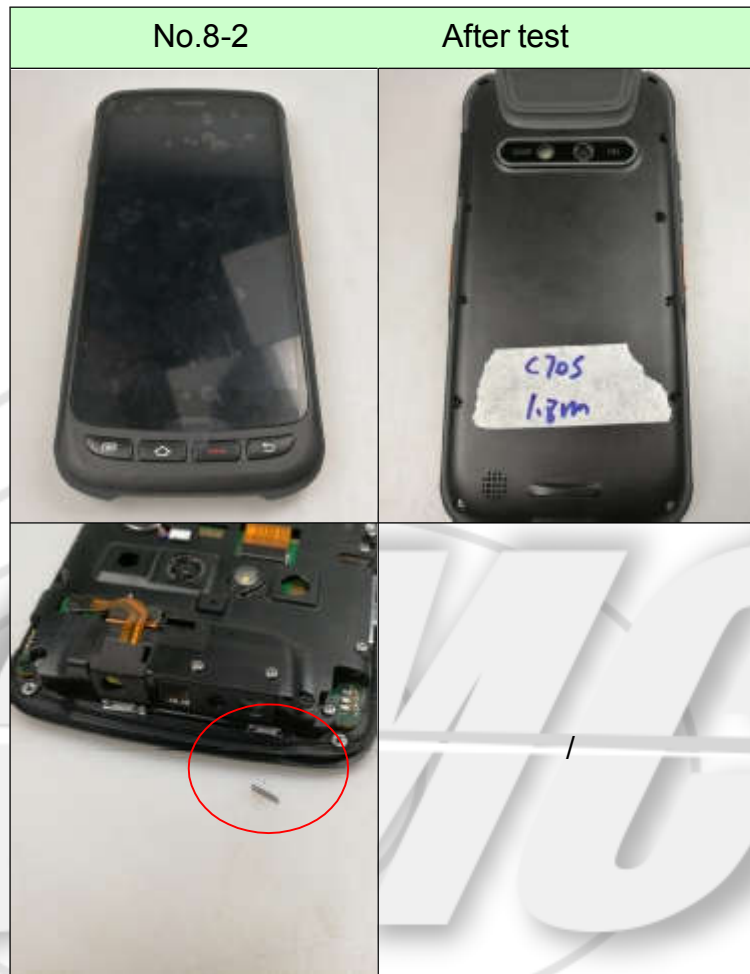
8. Test Photo :

No.	Test part	Test Symptom		
		1cycle	2cycle	3cycle
LHJ1700860_1-01#	rear	No damage	No damage	No damage
	left	No damage	No damage	No damage
	right	No damage	No damage	No damage
	top	No damage	No damage	No damage
	bottom	No damage	No damage	No damage
	front	No damage	No damage	No damage
	left	No damage	/	/
	right	No damage	/	/
	Plastic inside of the shell fell off after 20 times			
Test conclusion	PASS
